AFWAL-TR-85-3125

AIRCRAFT TRANSPARENCY TEST METHODOLOGY

Final Technical Report for Period June 1984 - September 1985

FLIGHT DYNAMICS LABORATORY
AIR FORCE WRIGHT AERONAUTICAL LABORATORIES
AIR FORCE SYSTEMS COMMAND
WRIGHT-PATTERSON AIR FORCE BASE, OHIO 45433

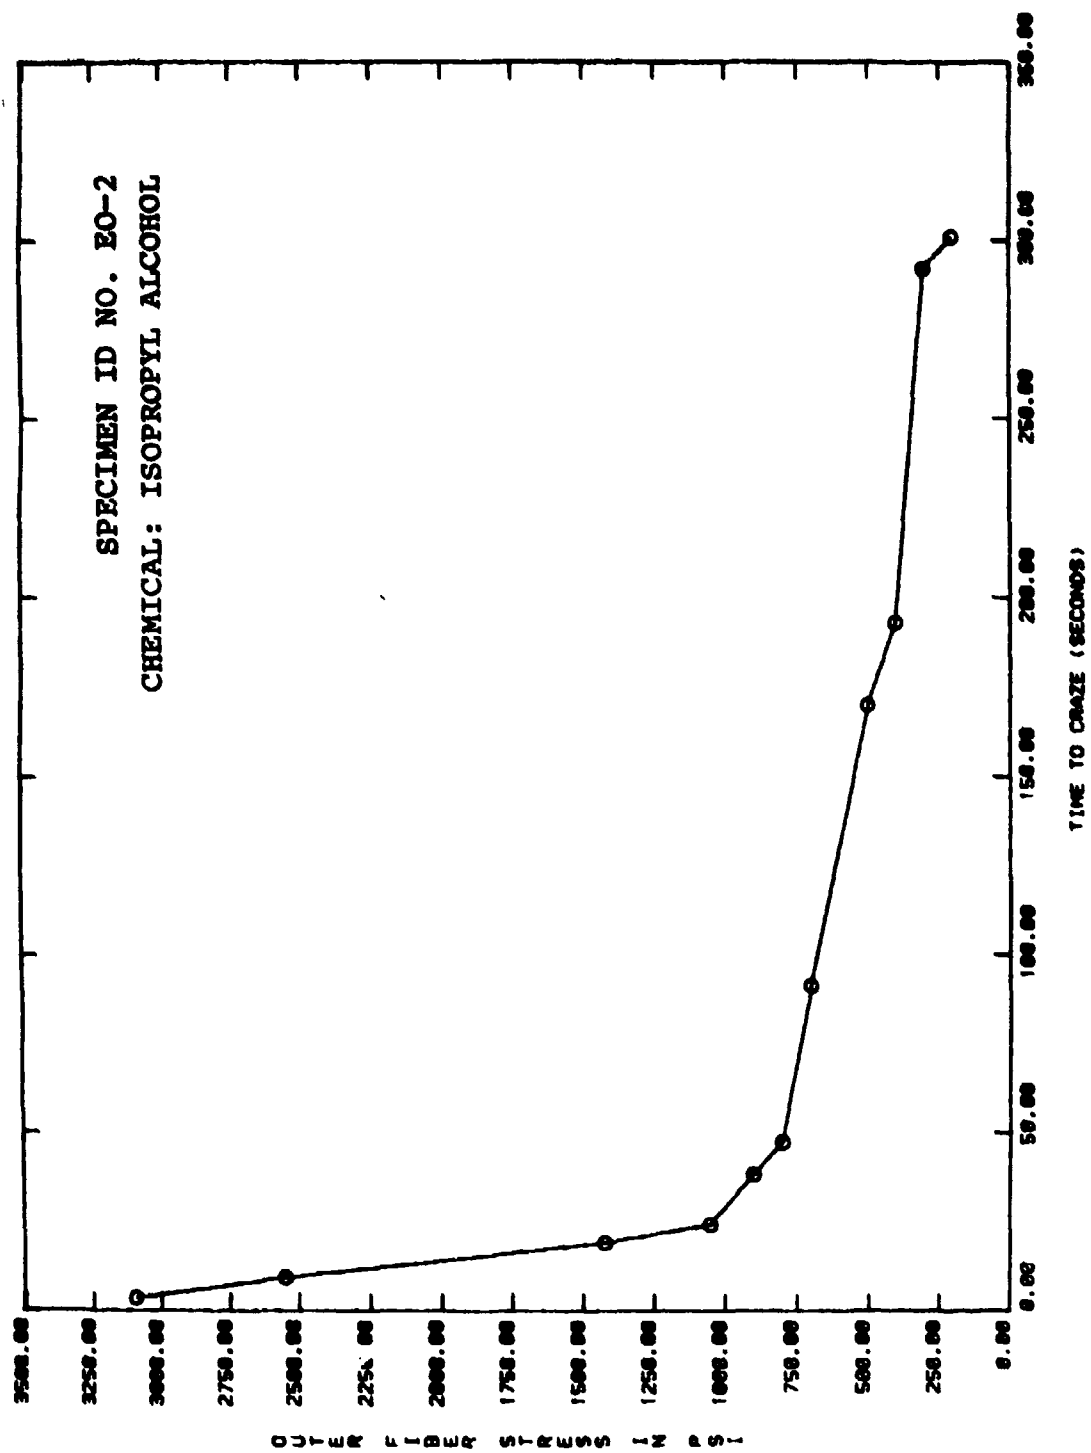
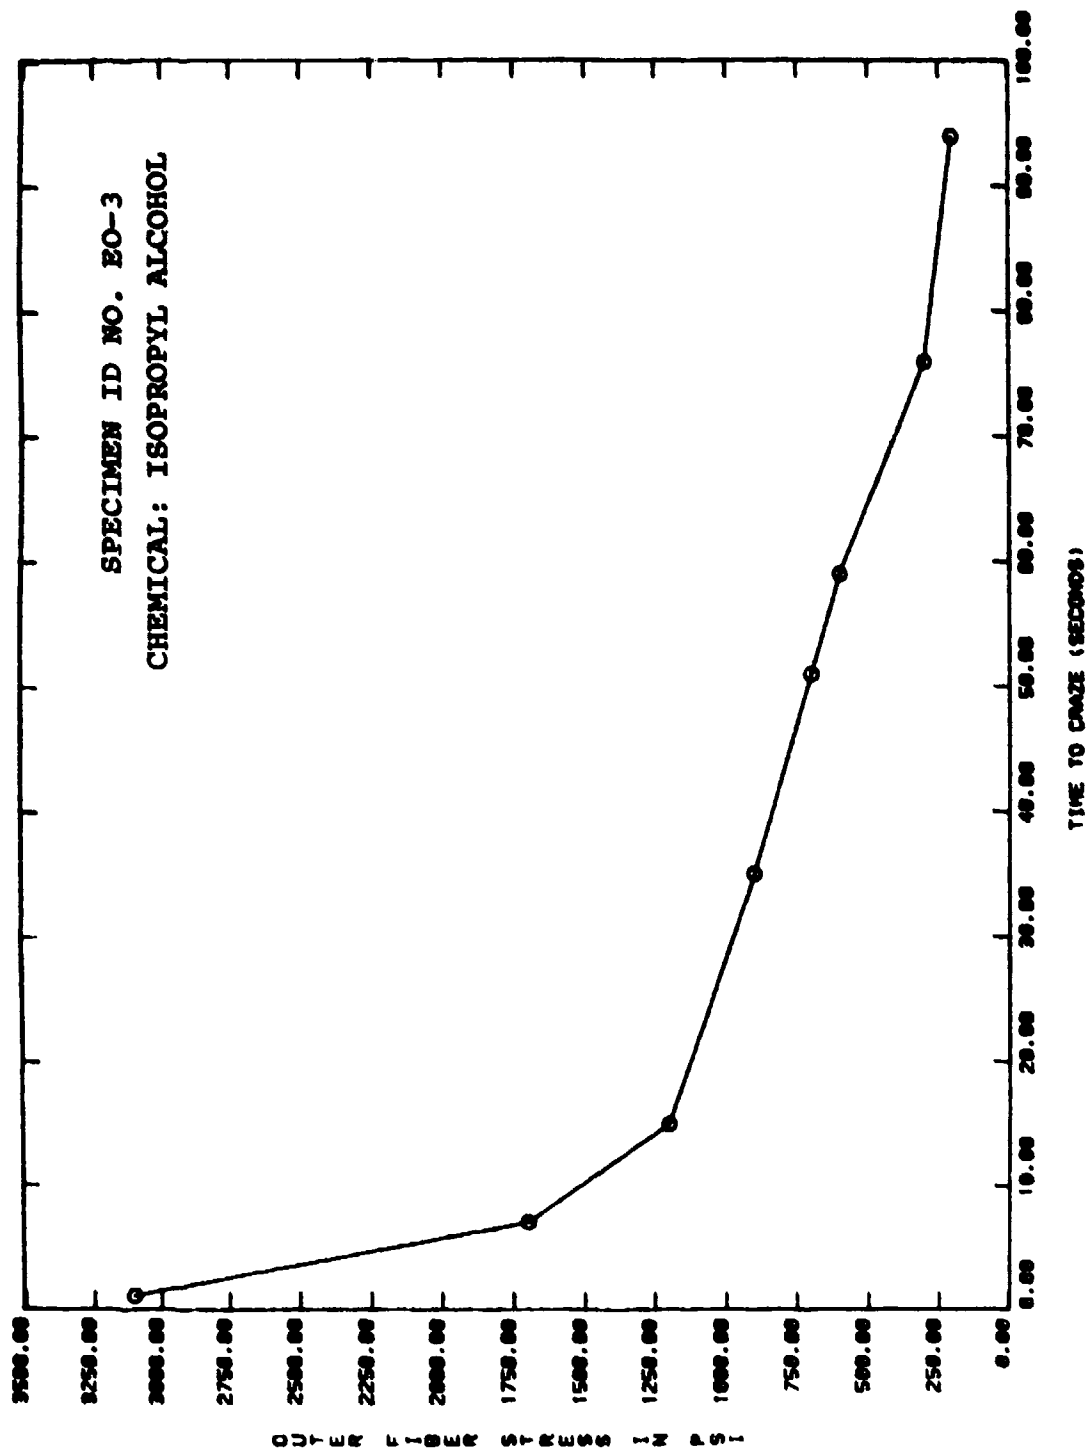
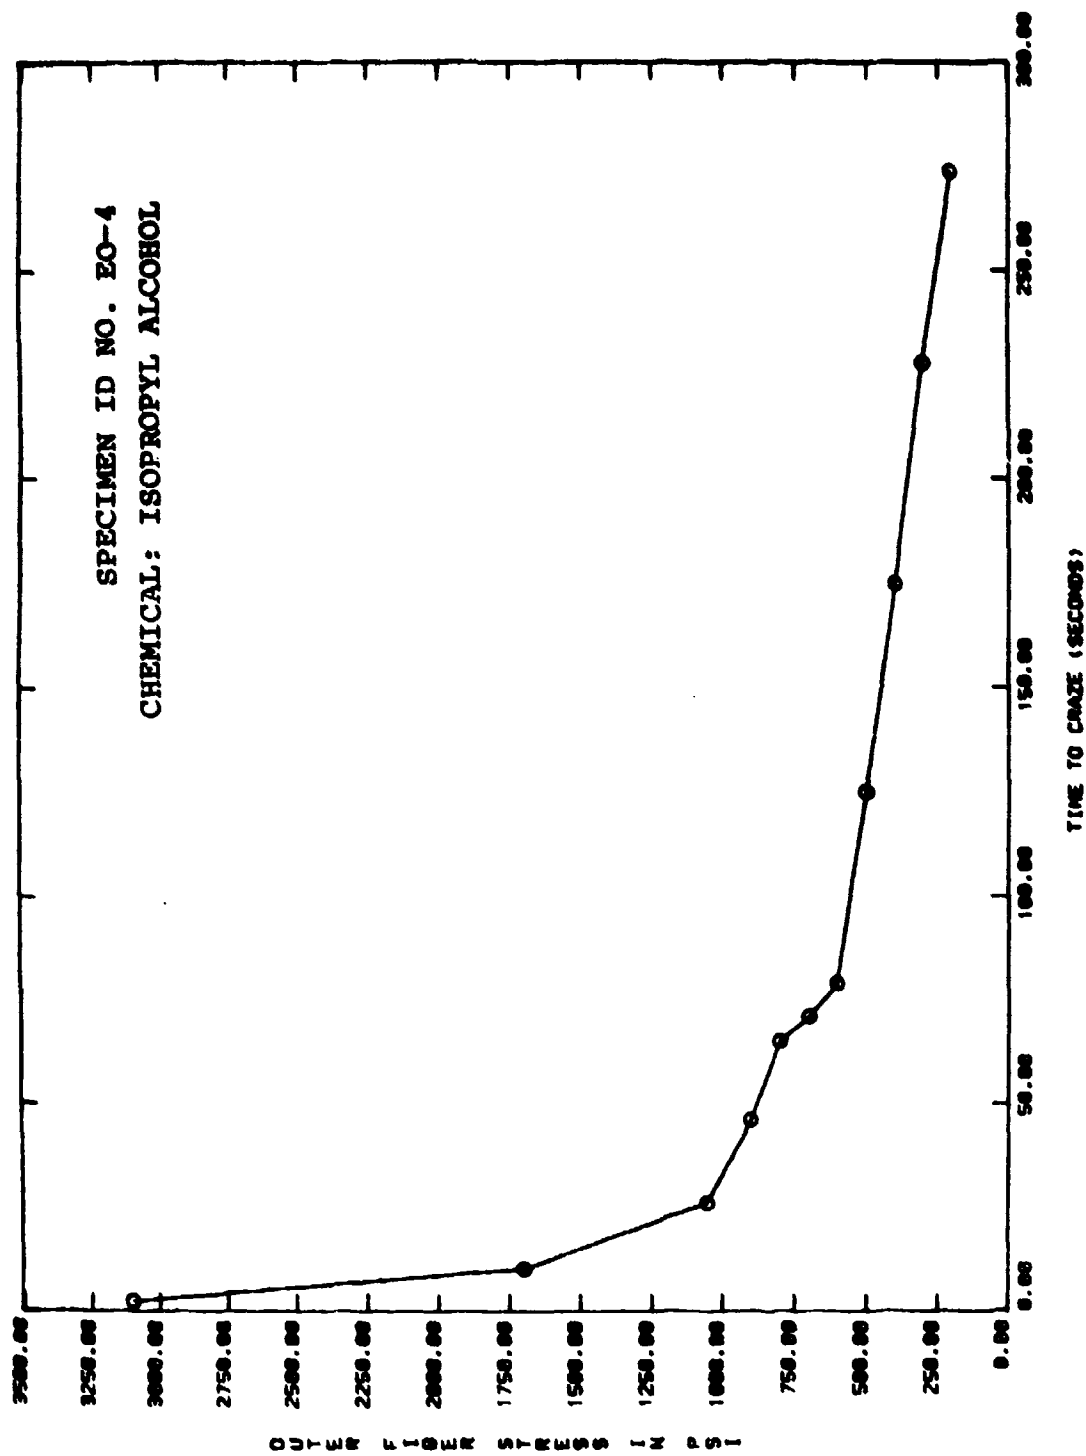
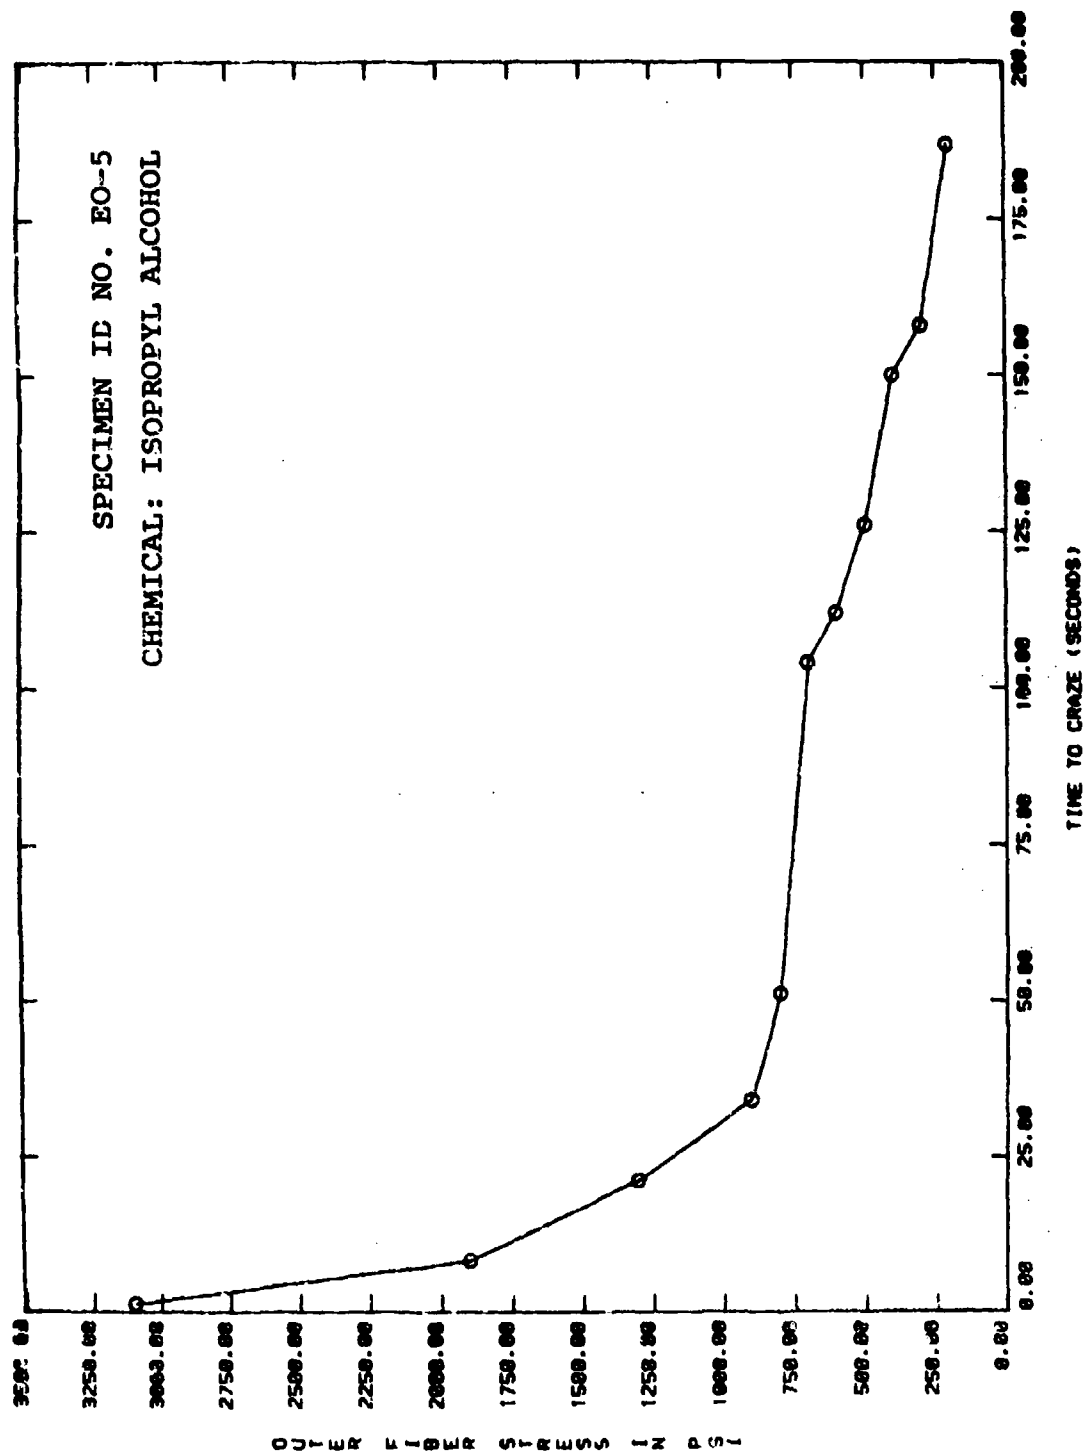
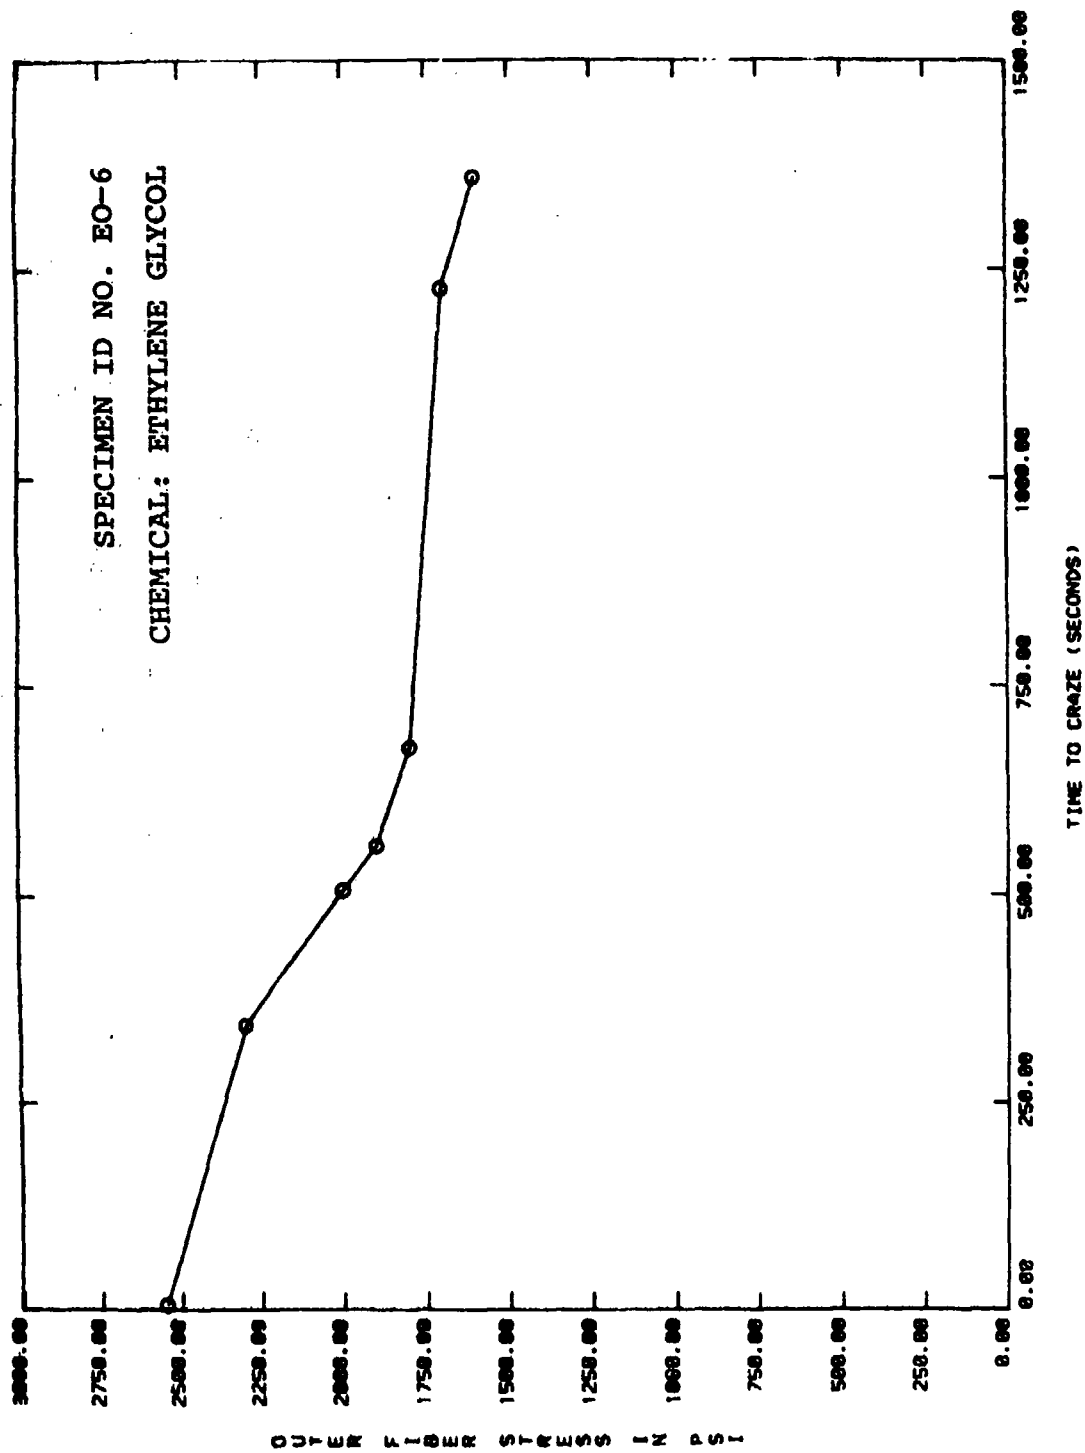
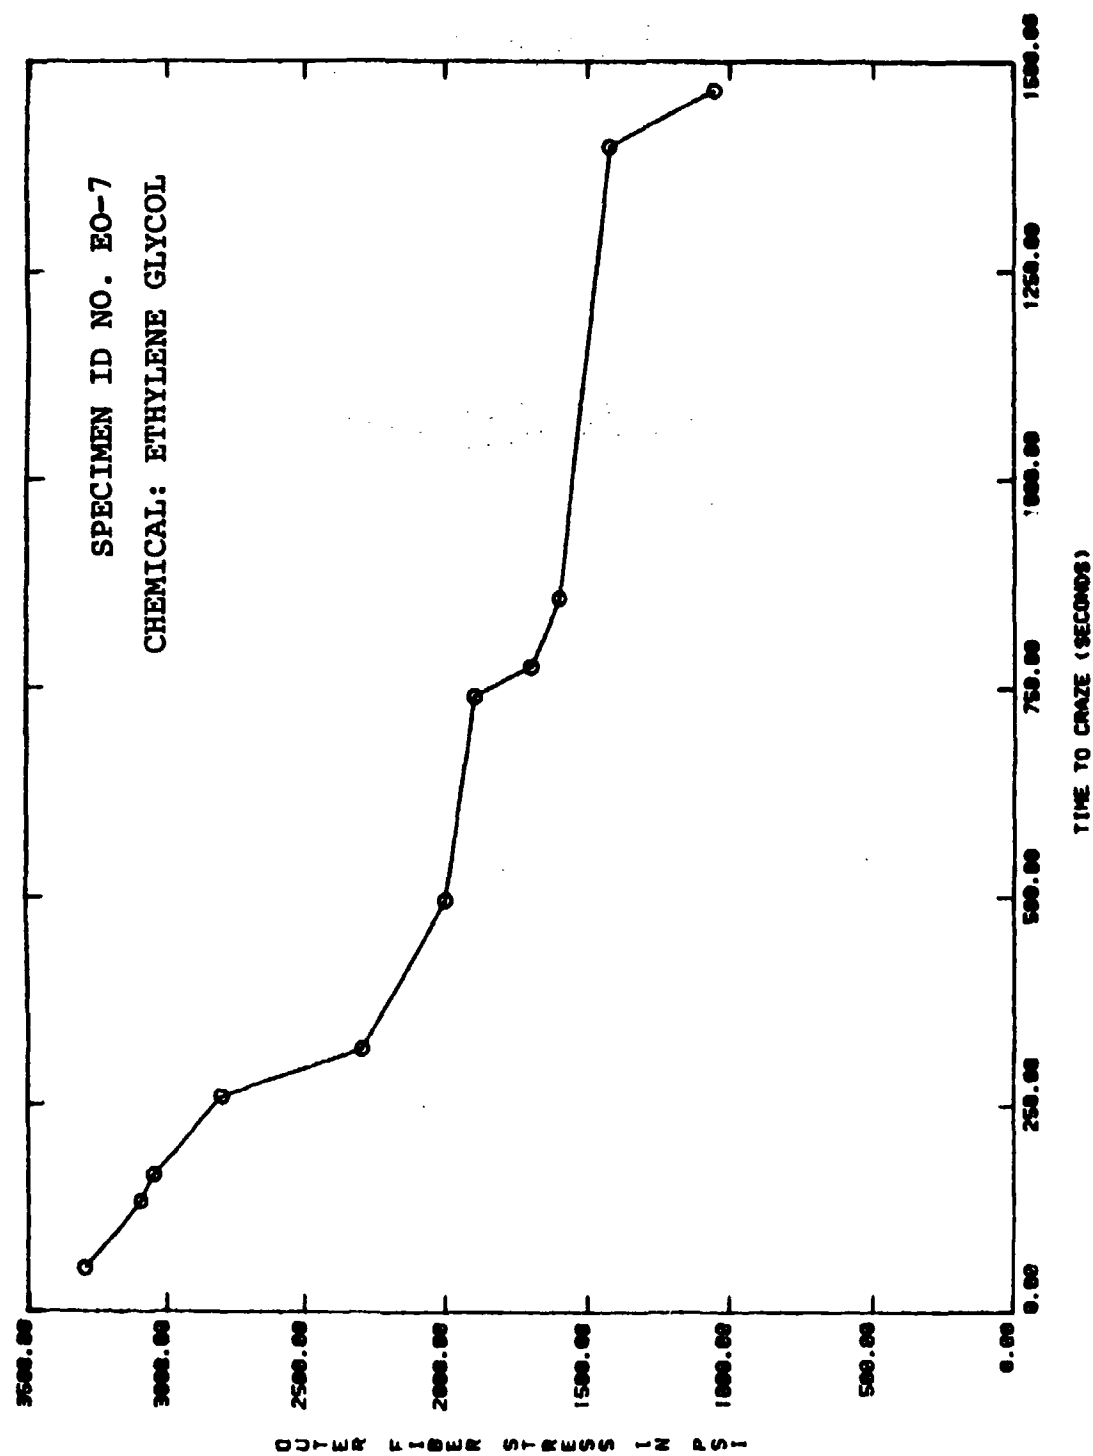
Figure A-14. Plots of Outer Fiber Stress versus Time to Craze for the F-111 Laminated Windshield Specimens.
